Debris/Ice/TPS Assessment And Photographic Analysis For Shuttle Mission STS-31R

June 1990

Charles G. Stevenson
NASA/Kennedy Space Center

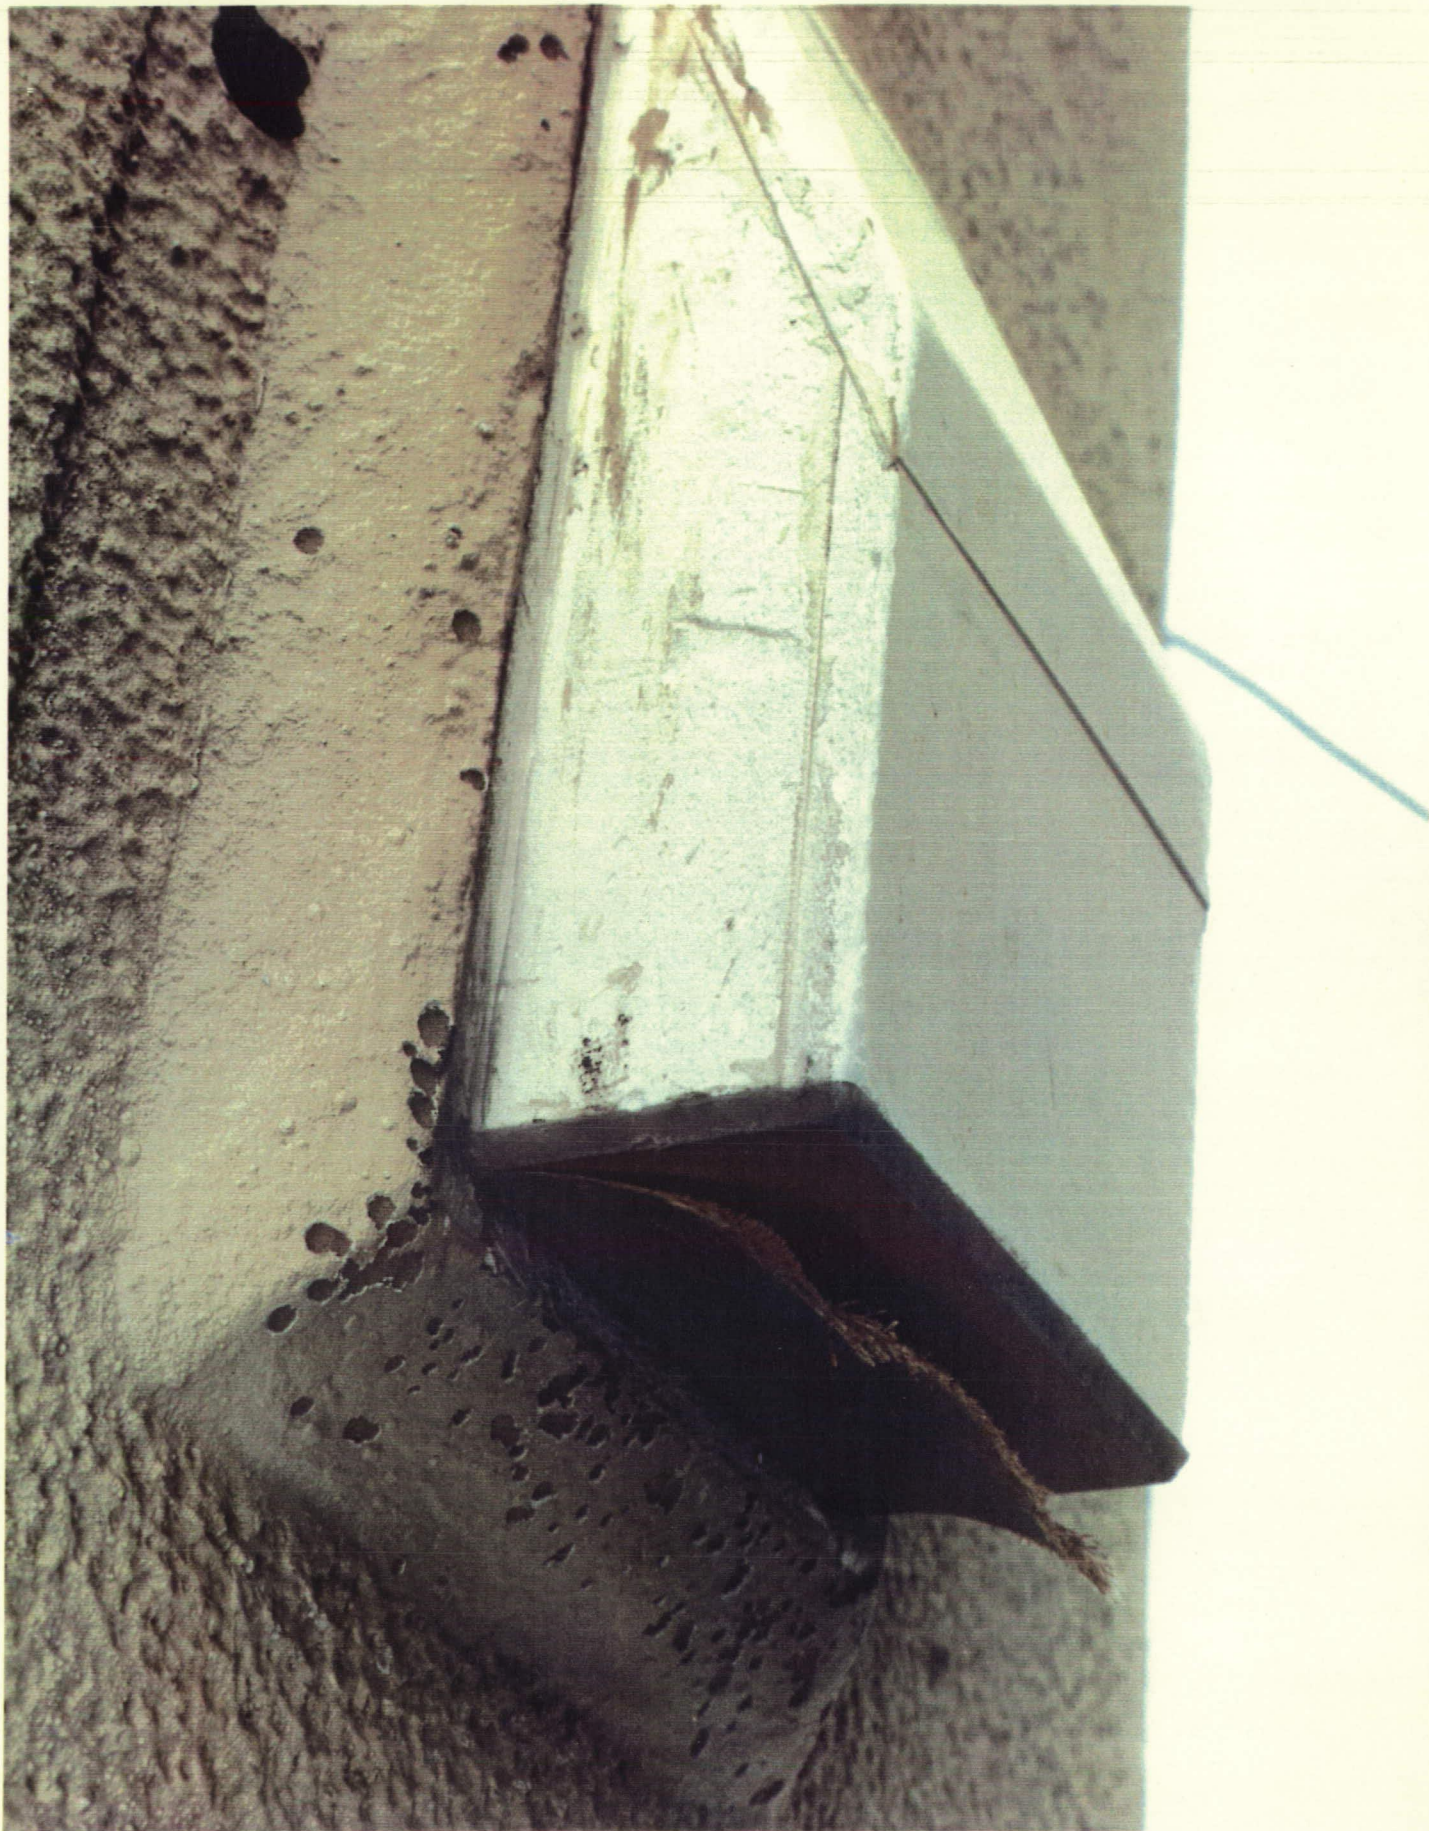
The phenolic plate on the -Z RSS antenna had some
delaminated layers

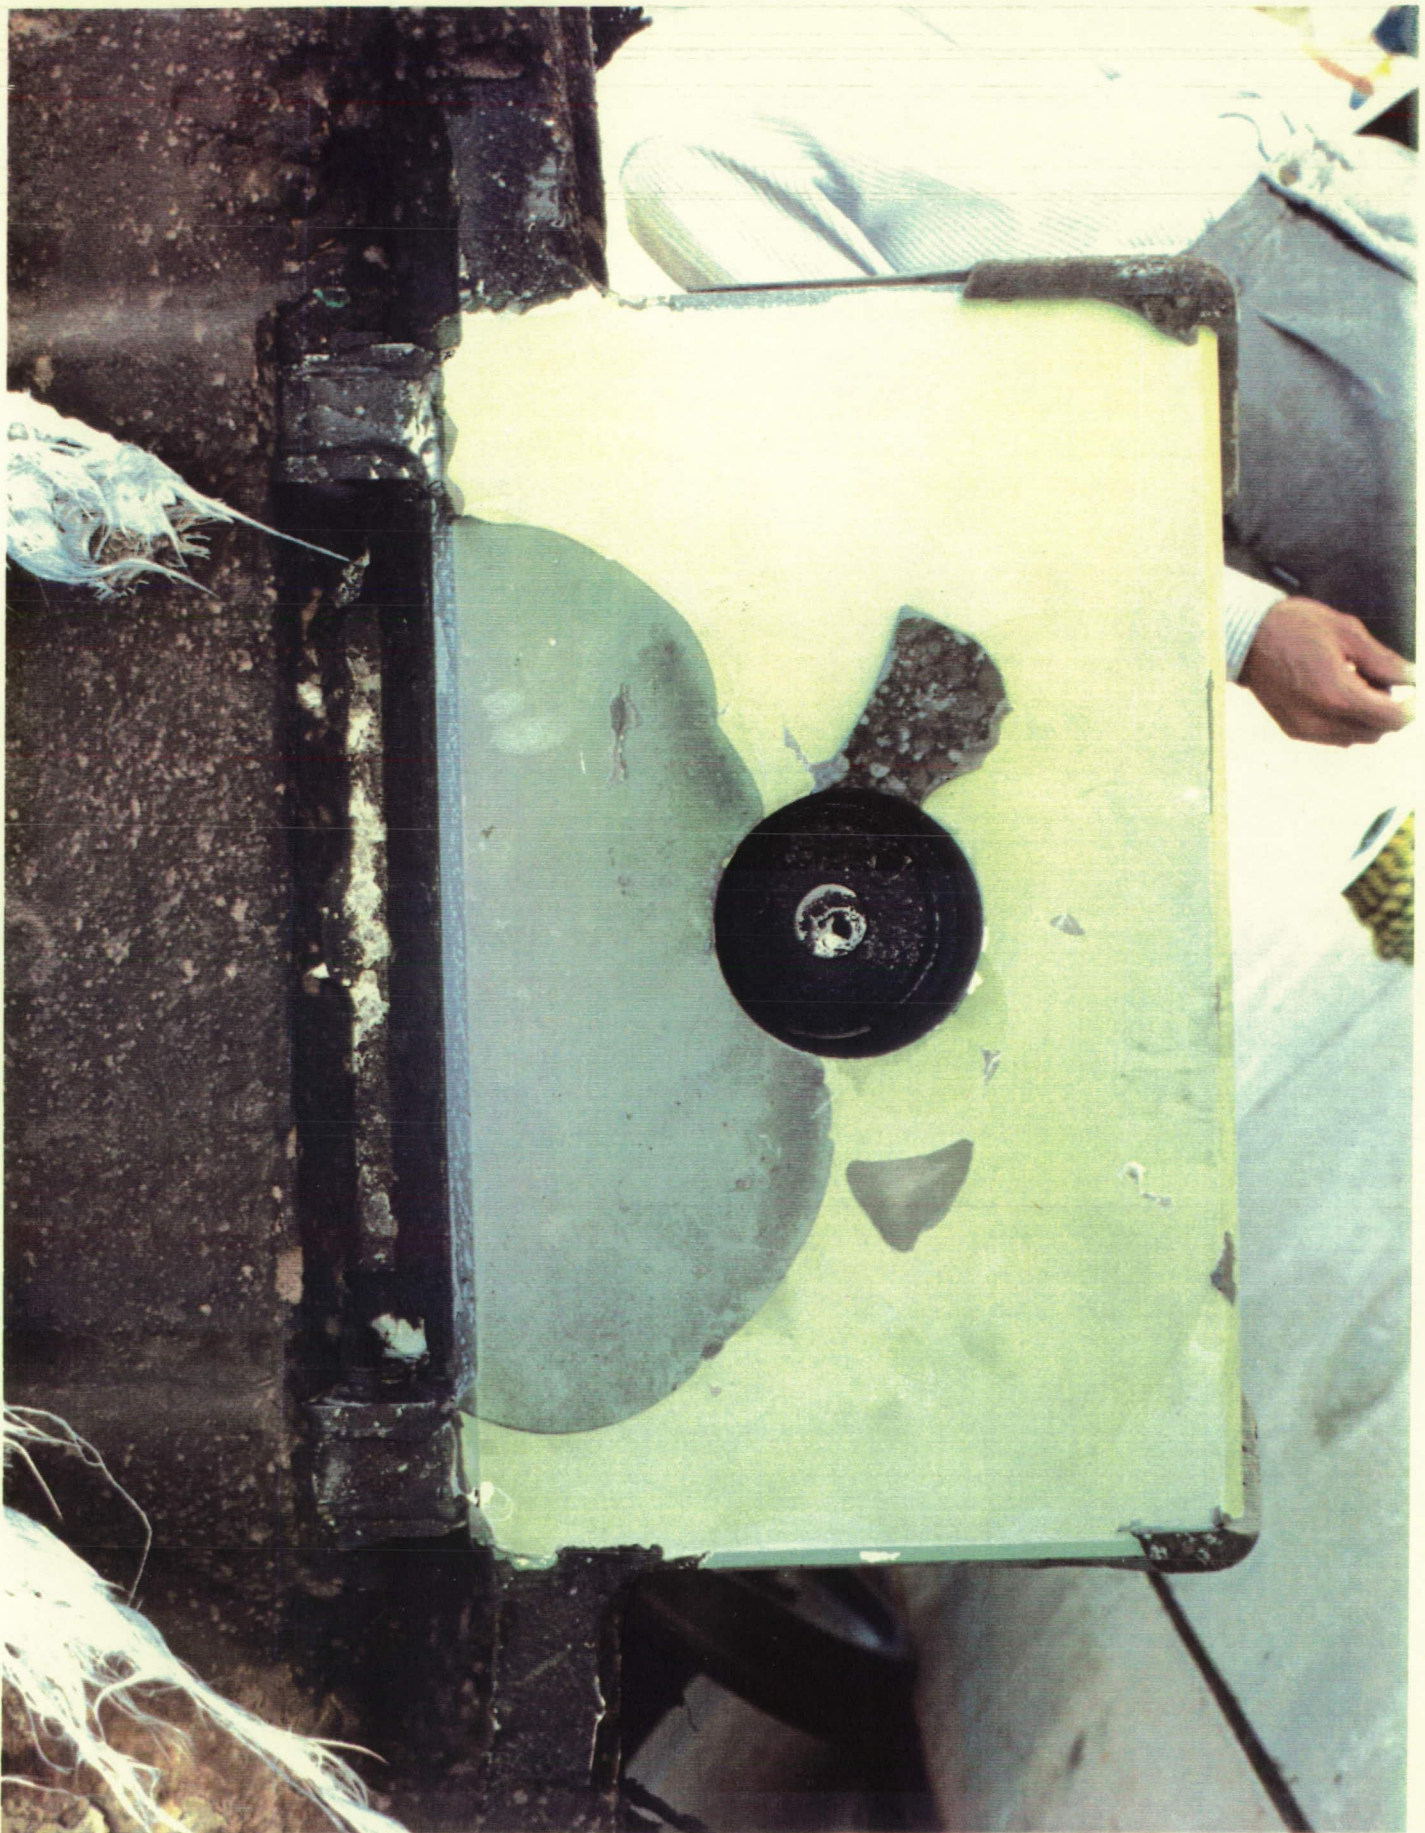
Some of the Epon shim material on HDP #4 was missing prior
to water impact

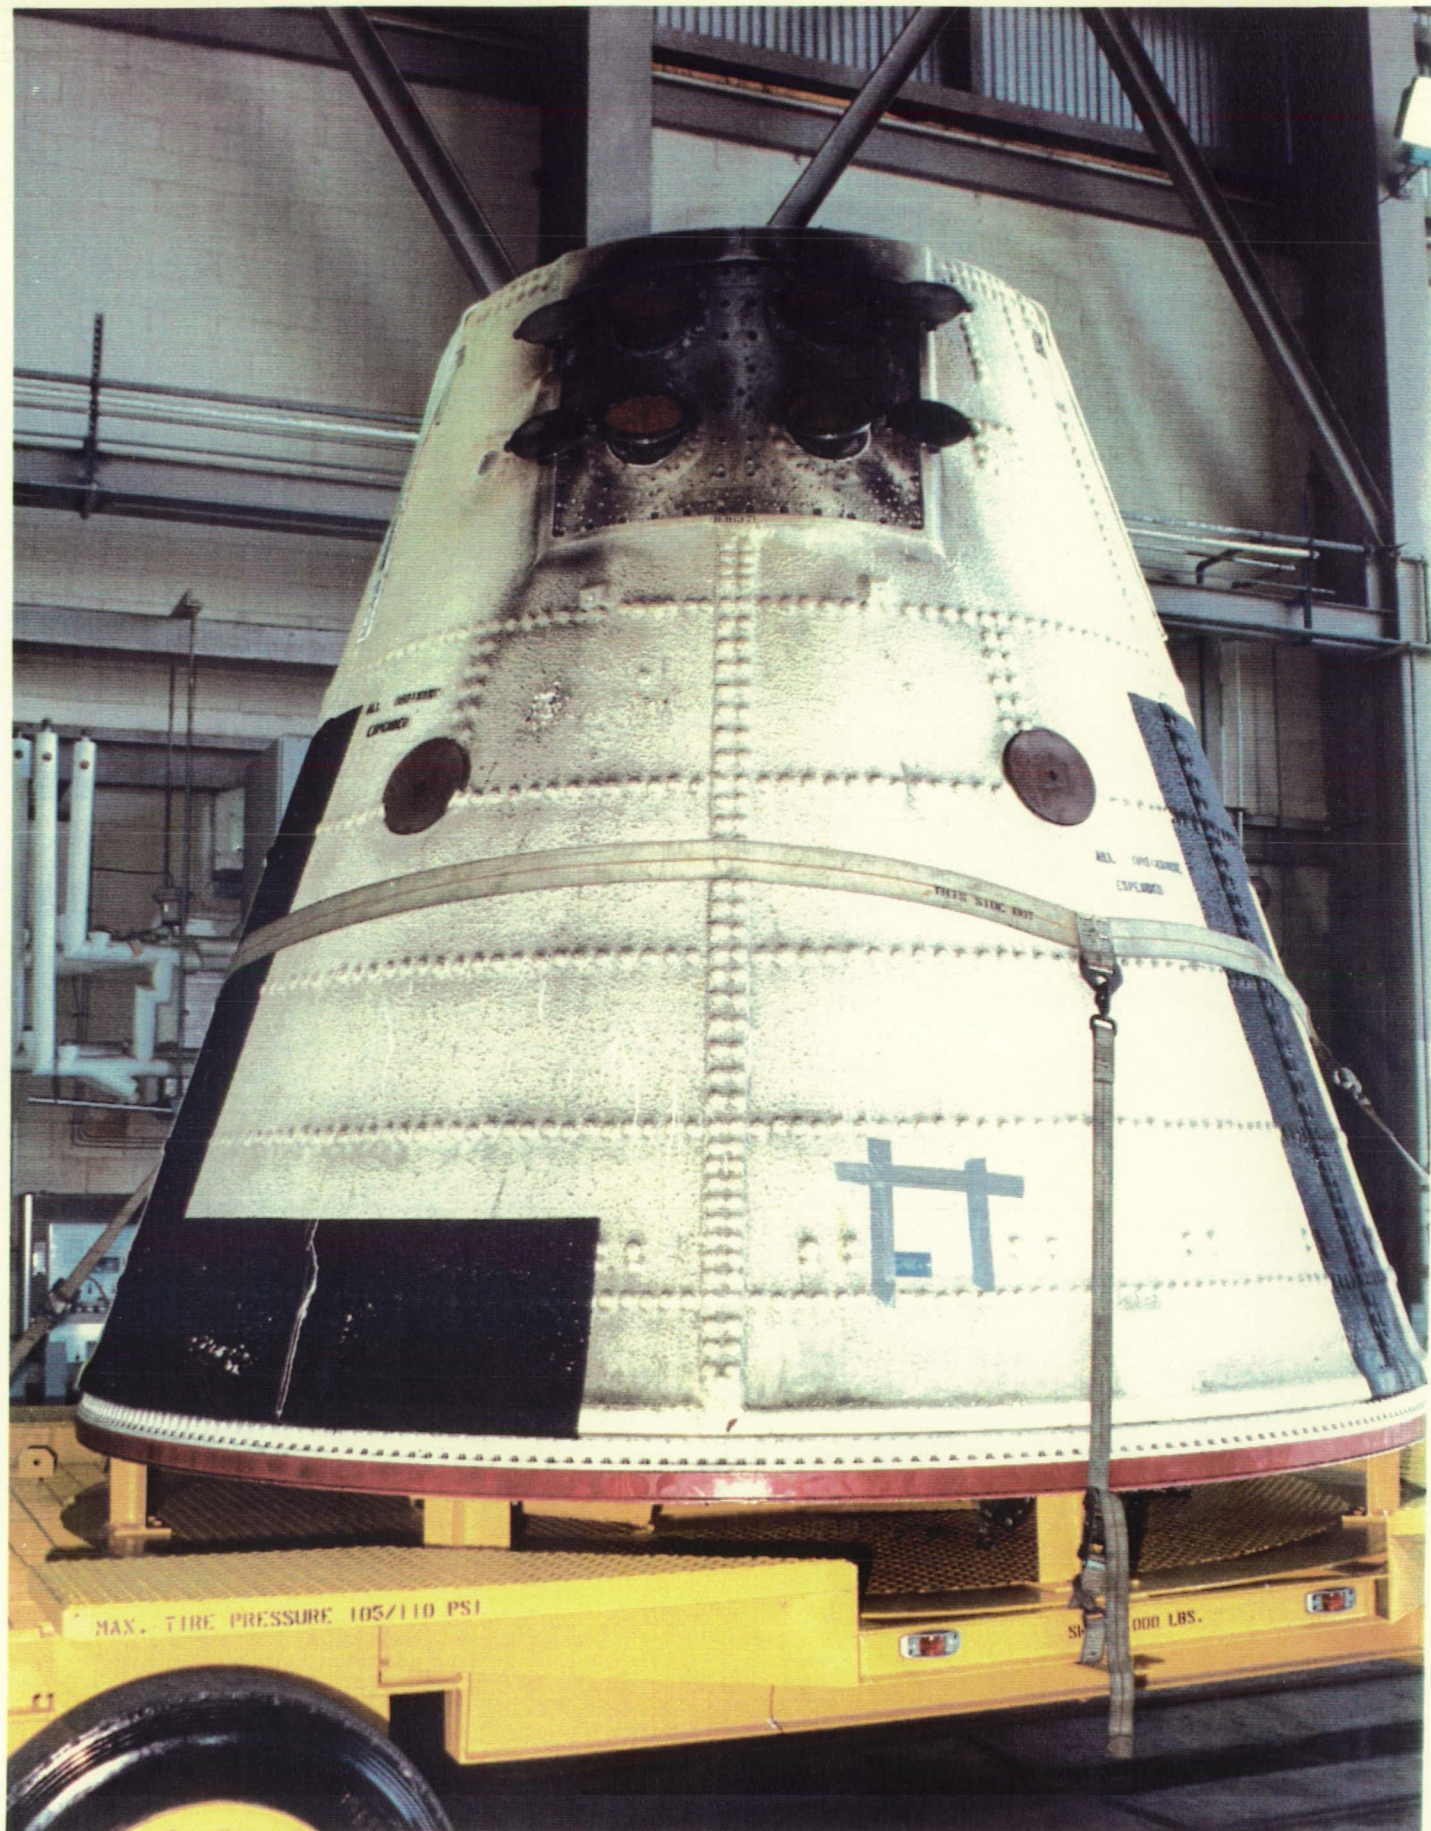
Post flight condition of the LH frustum. There were 7 debonds over fasteners, but no areas of missing TPS.

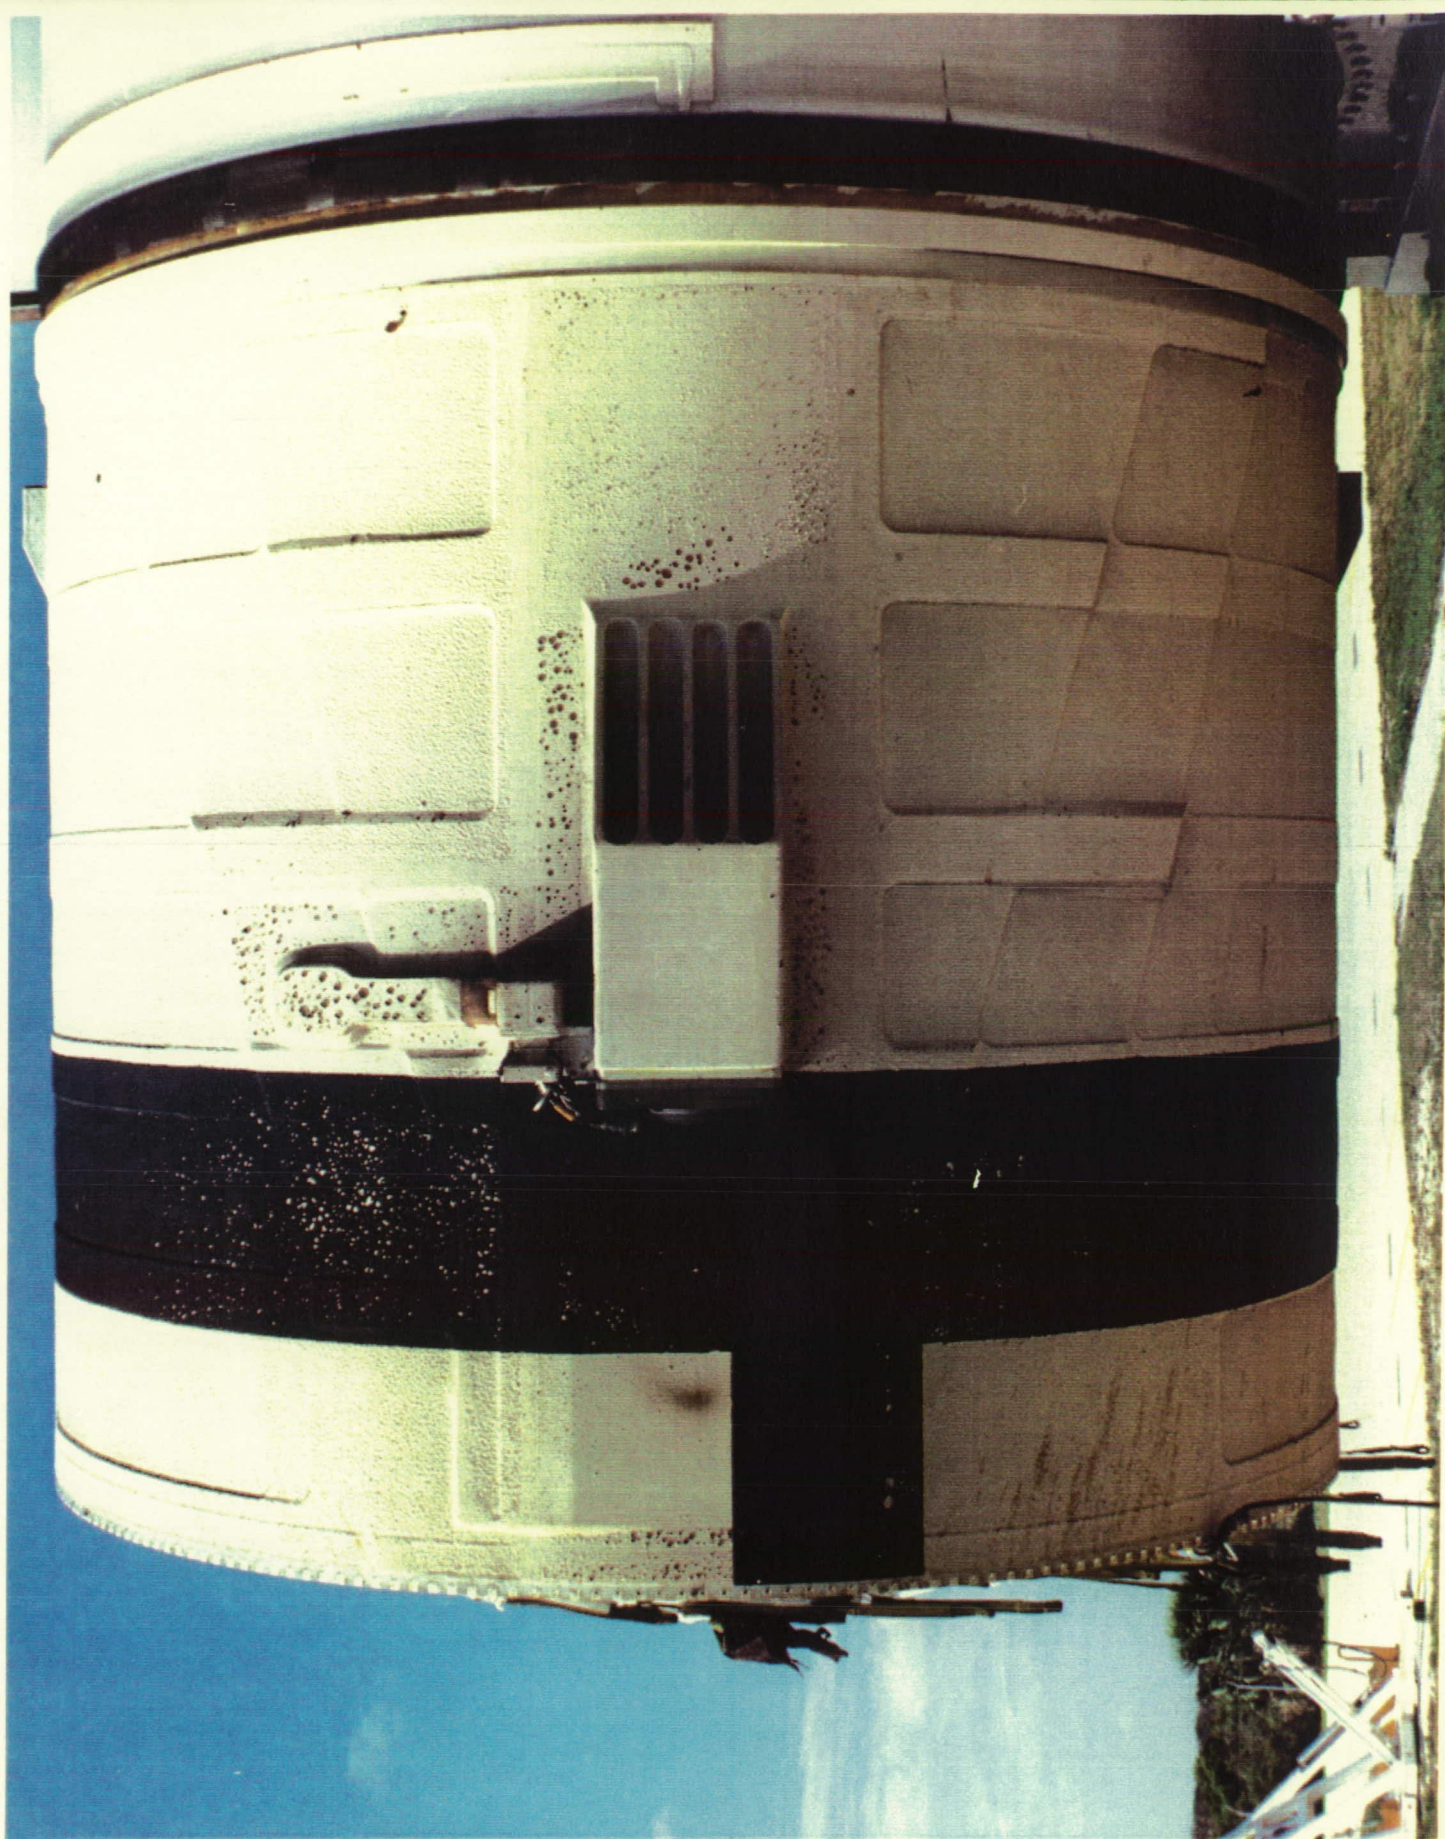
Post flight condition of the LH forward skirt. There were no debonds or areas of missing TPS.

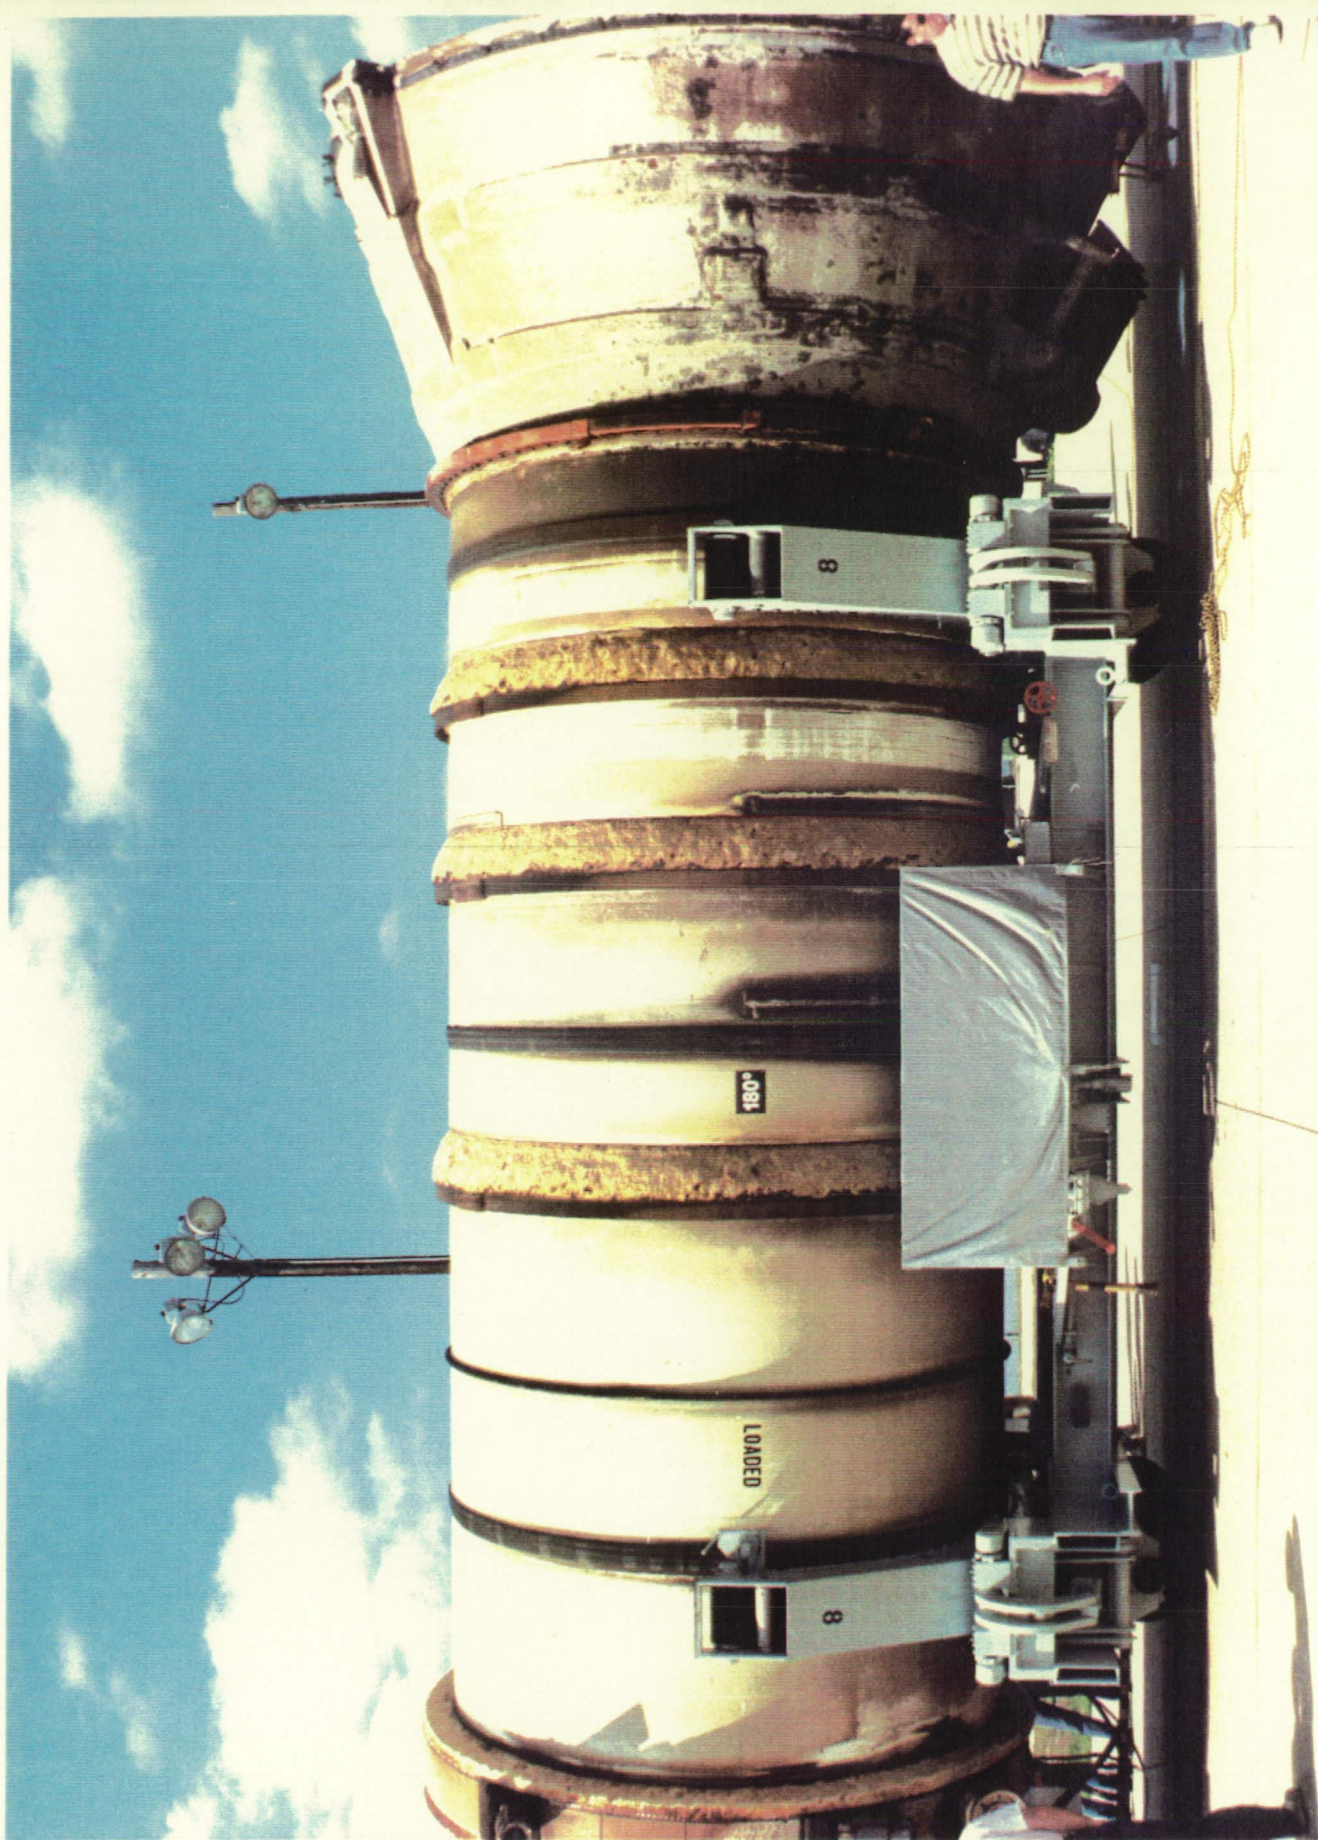
Post launch condition of the LH aft booster

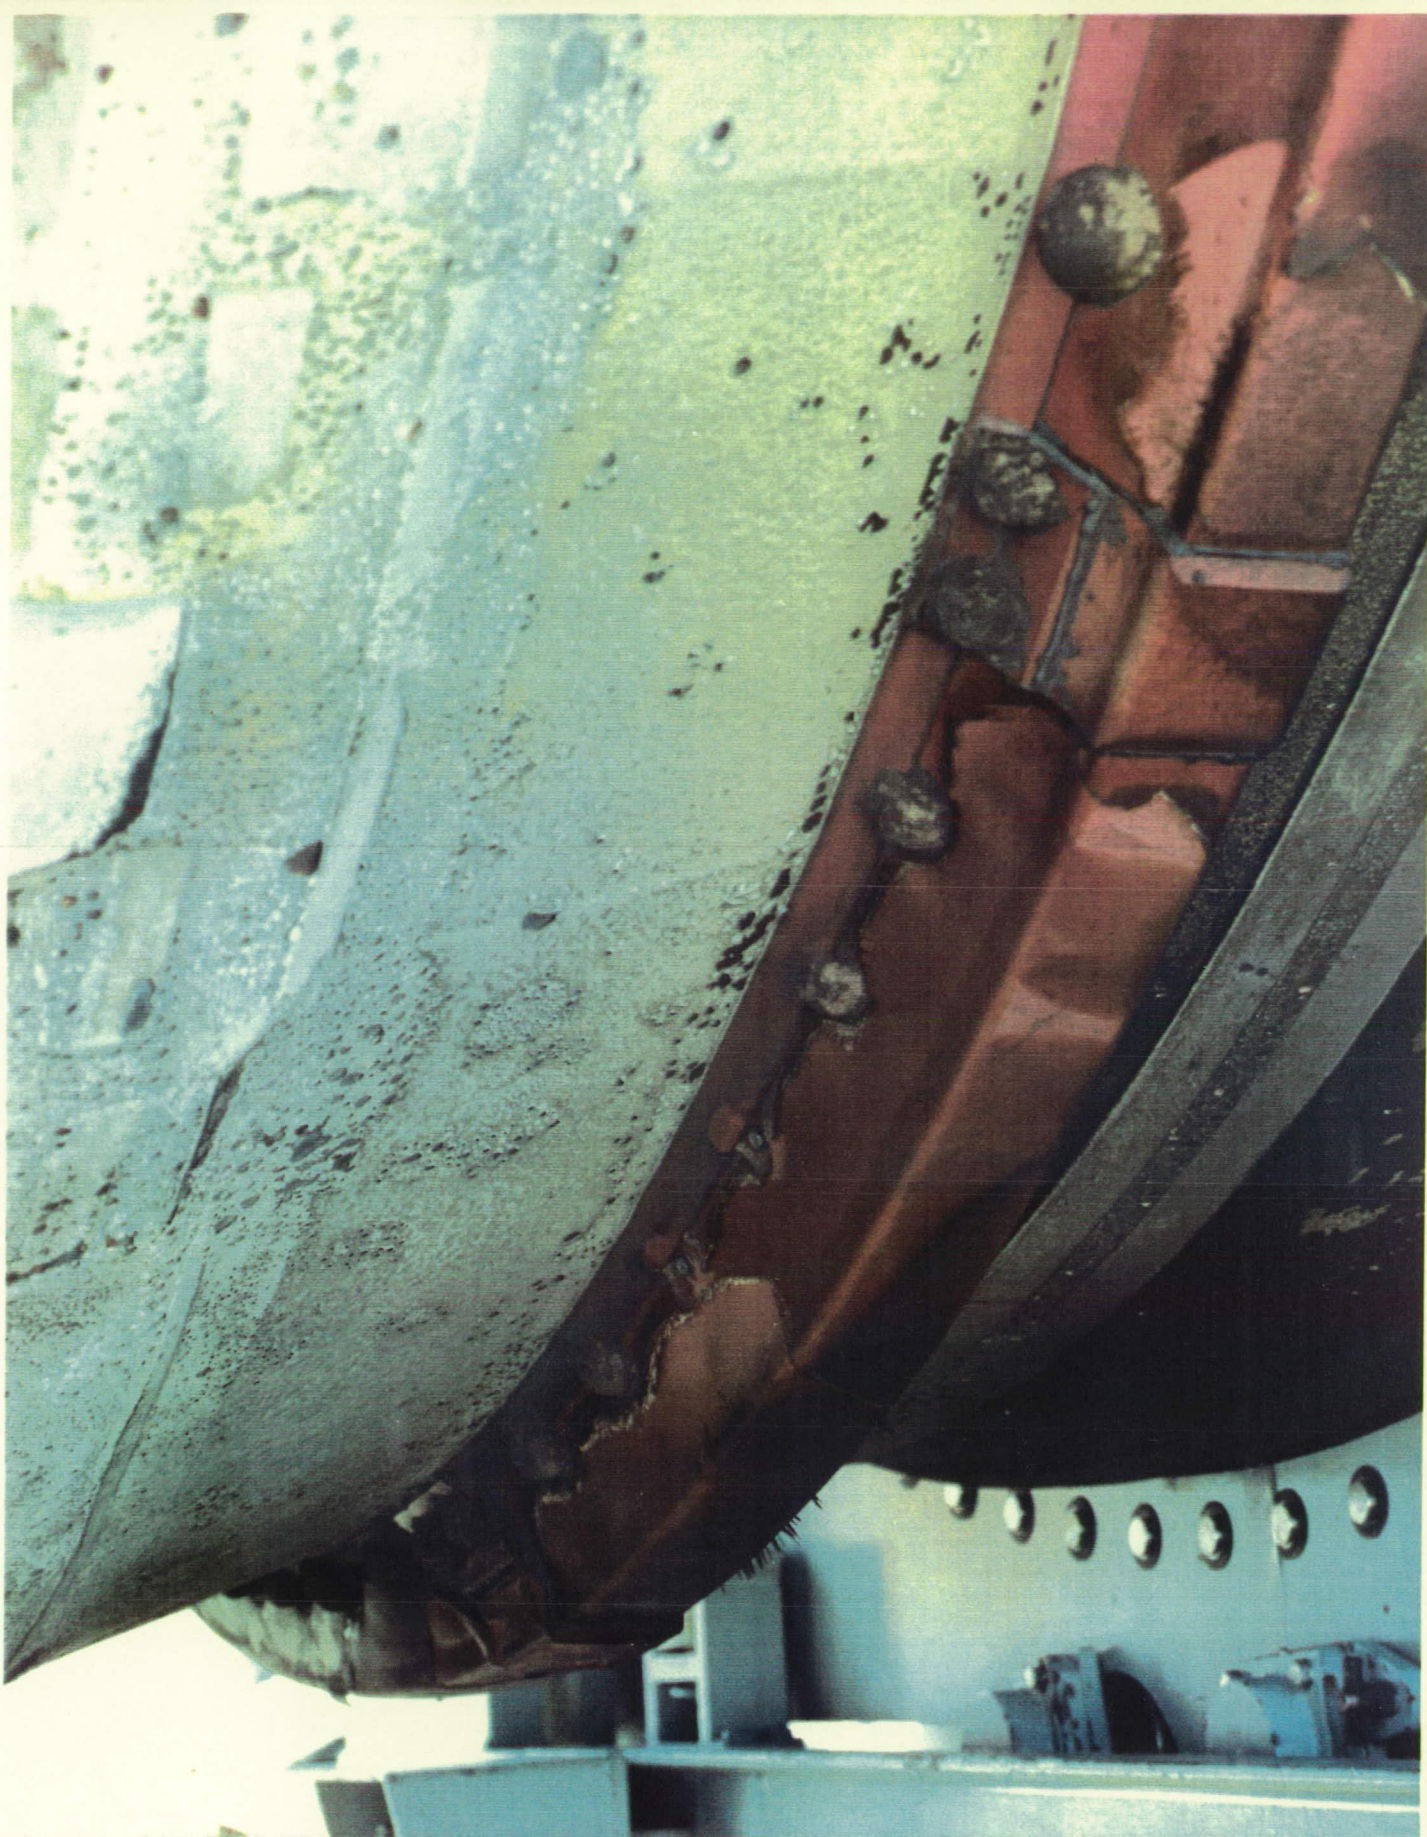
Phenolic material on the kick ring delaminated at several locations. K5NA protective domes were missing from boltheads.

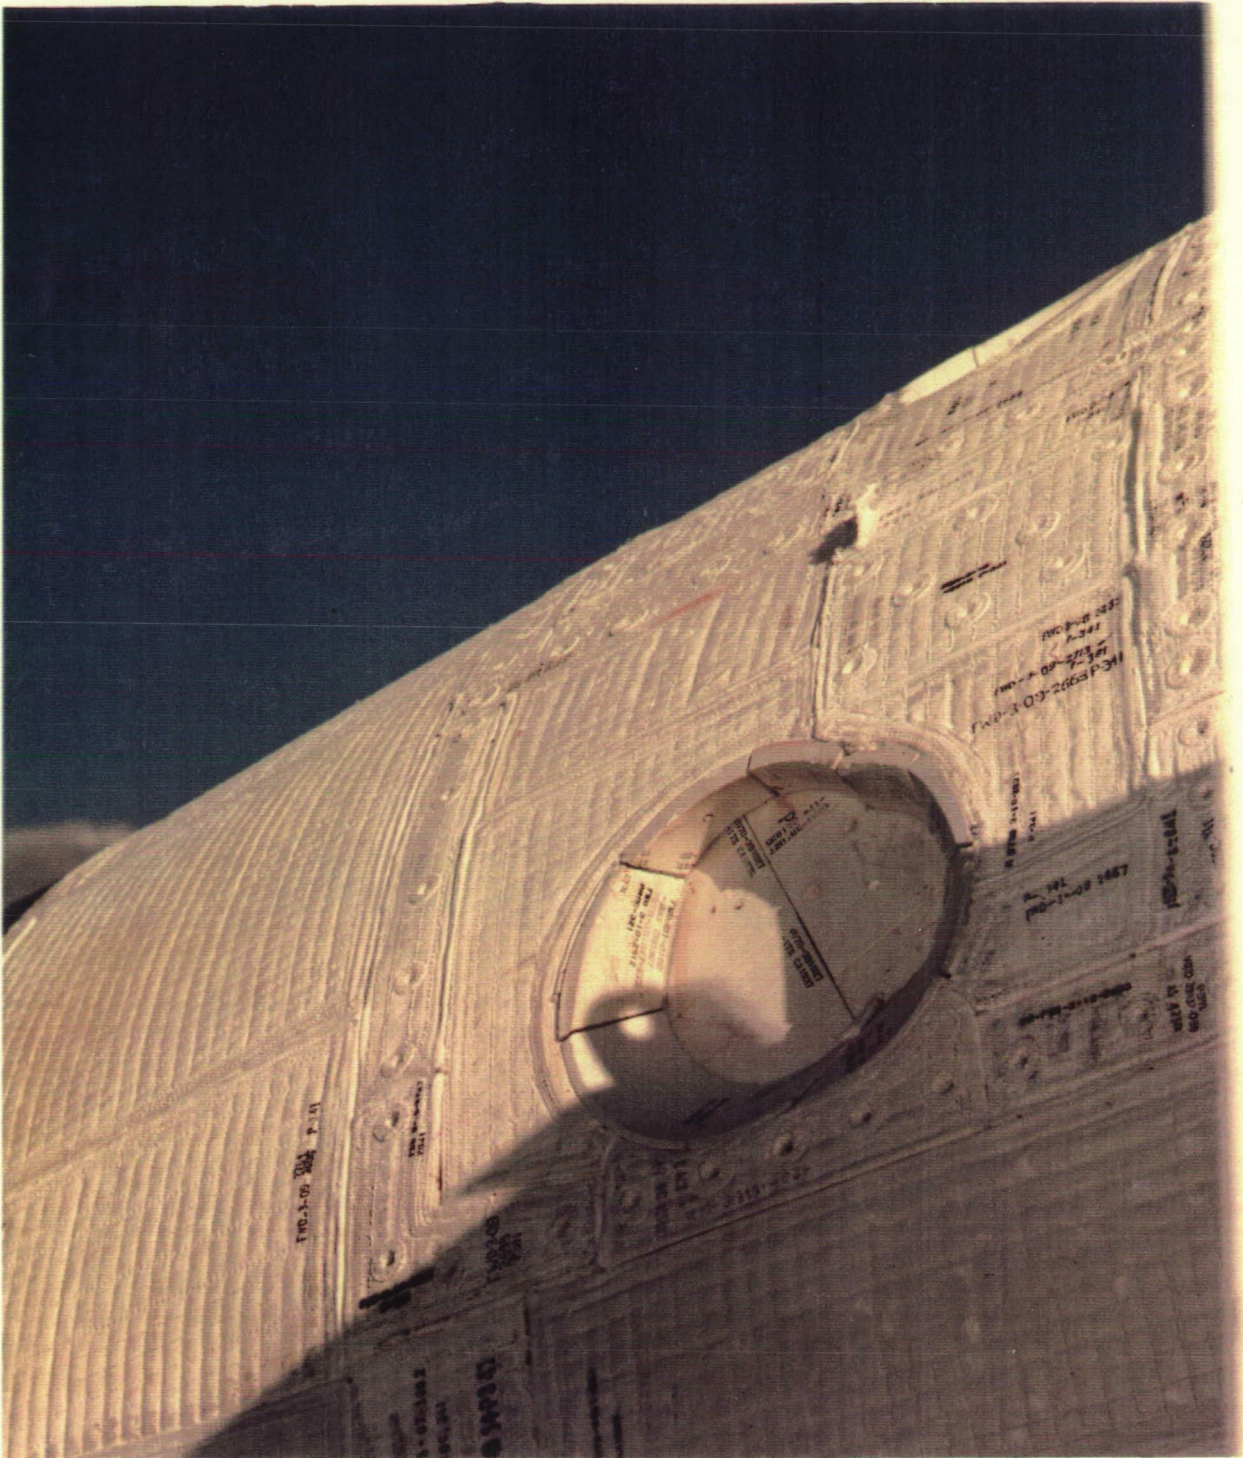
A 3"x3" tile corner was broken and loosely attached in the
Y star tracker cavity

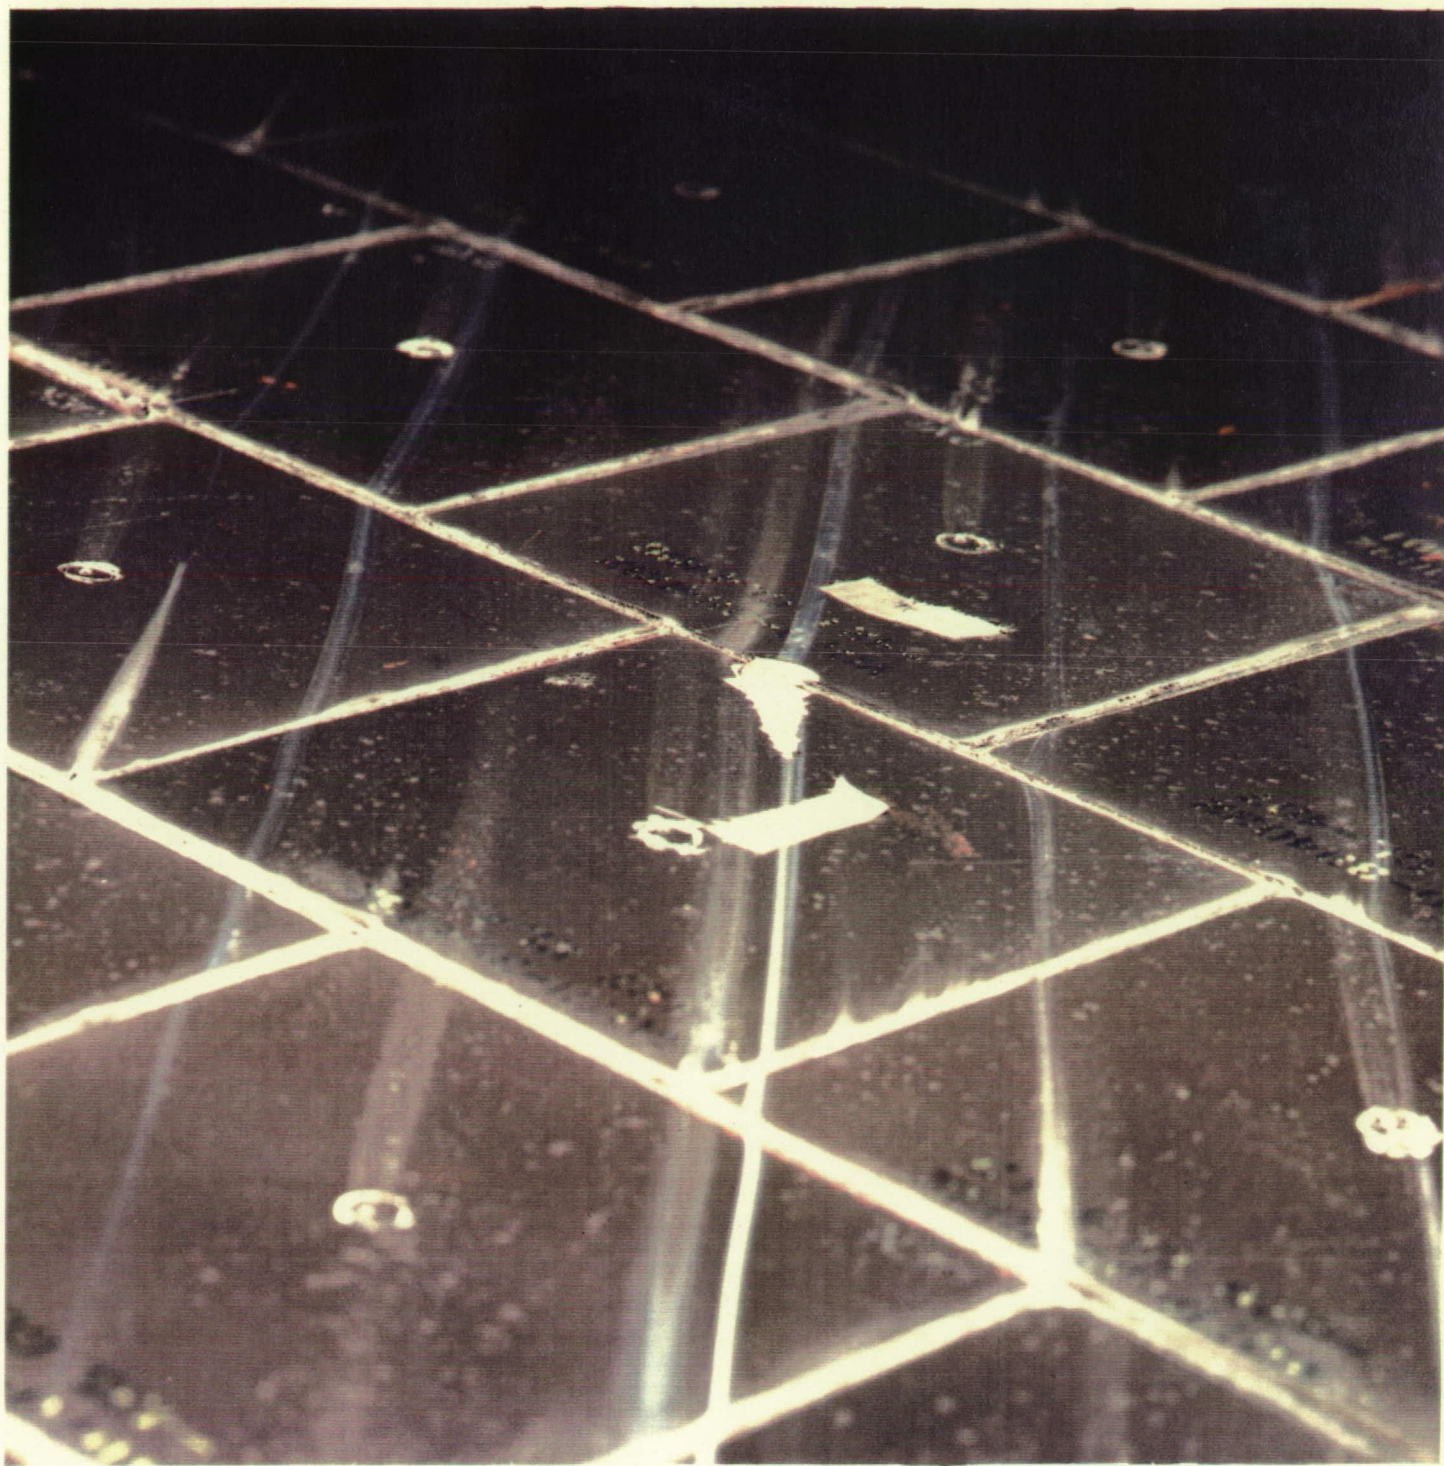
Typical debris impact damage to lower surface tile

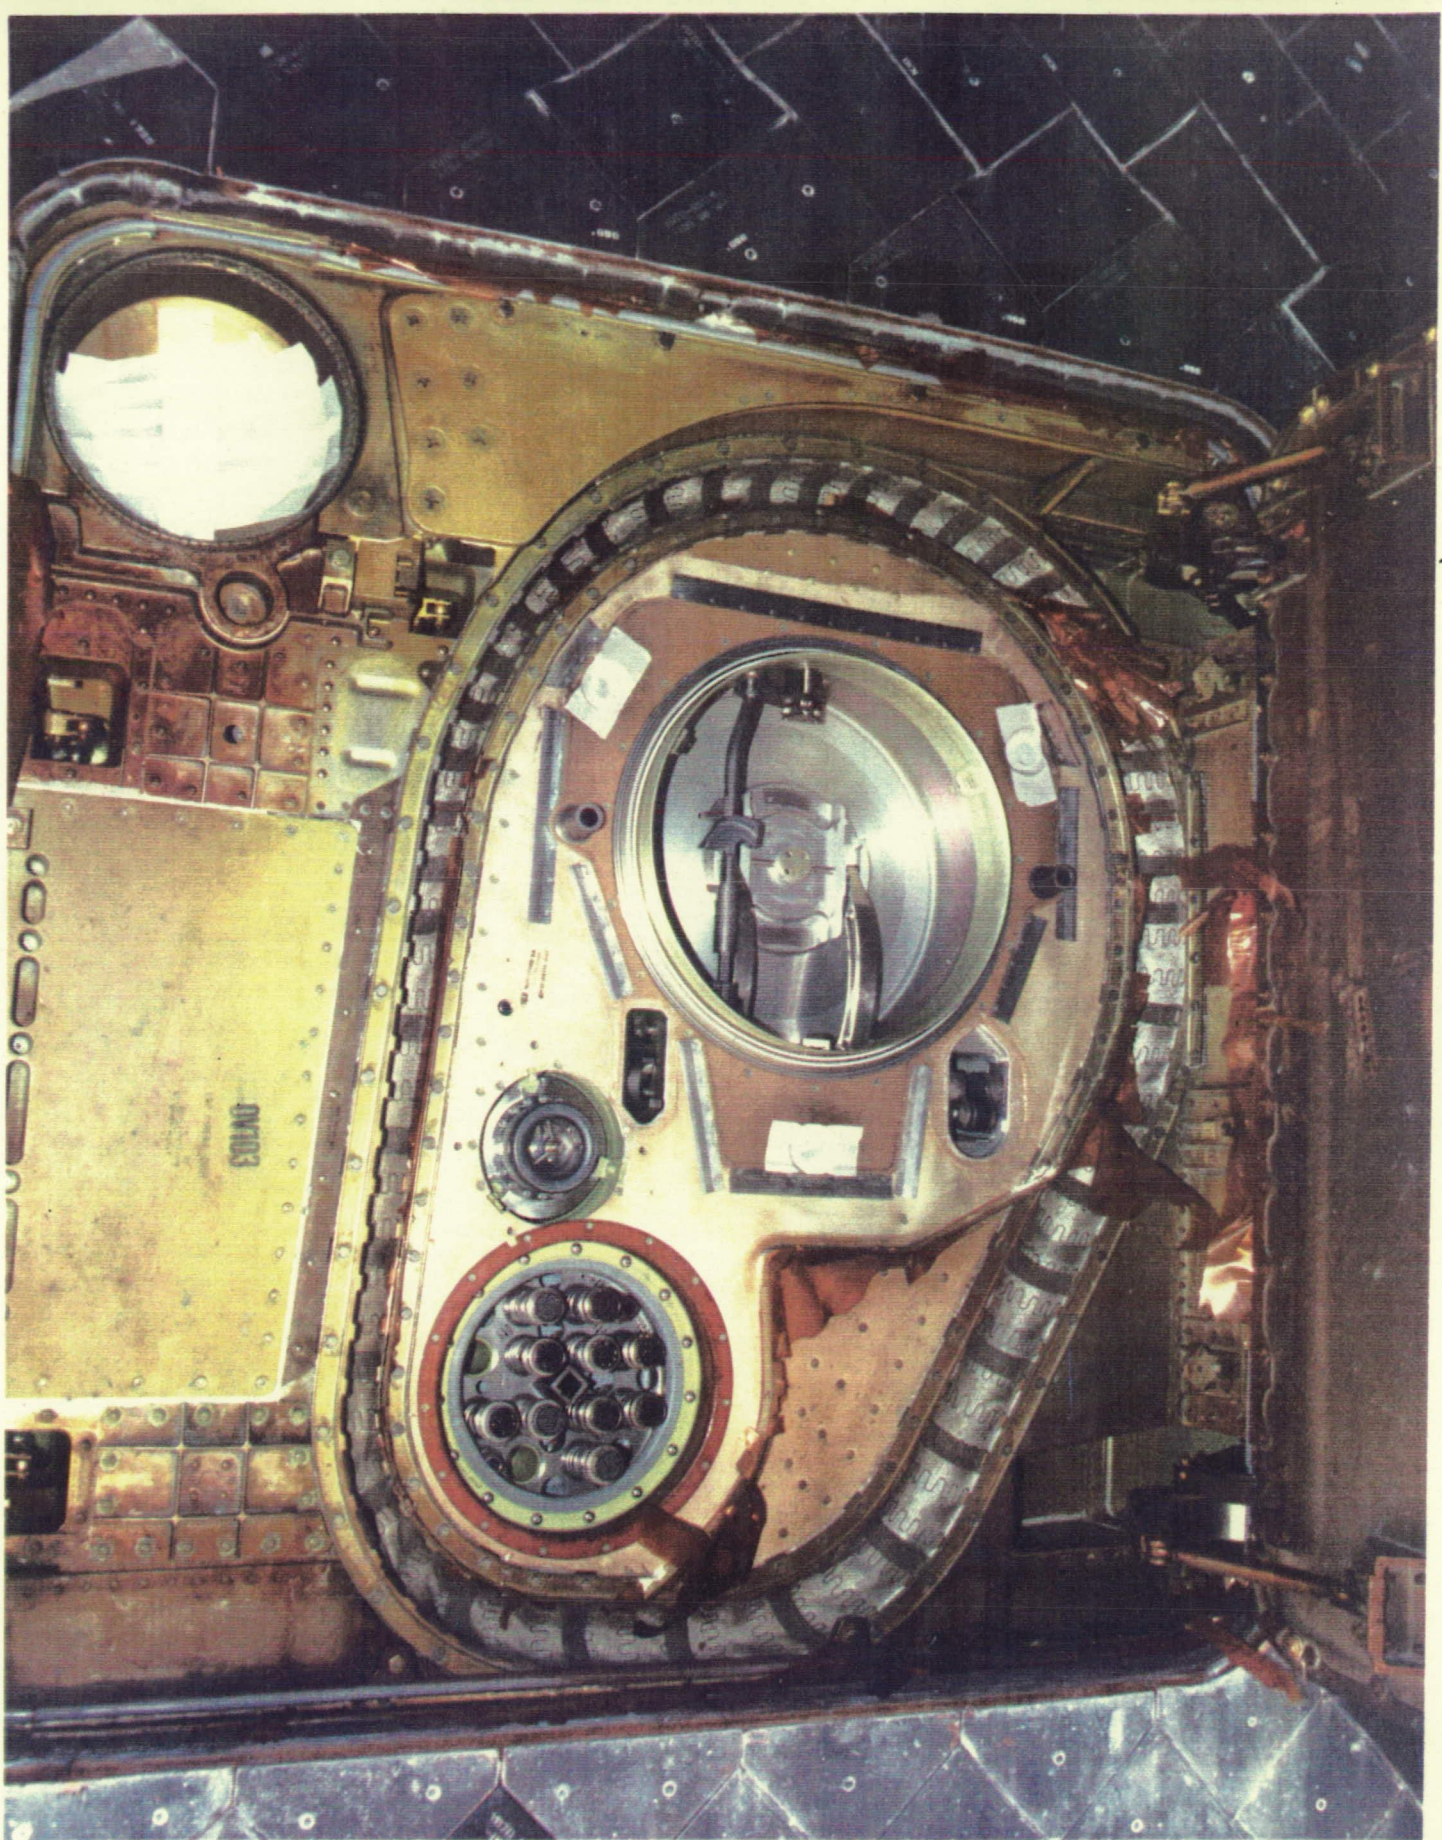
Post flight condition of the LO2 ET/ORB umbilical
145
